Tree Survey and Assessment

Lake Rd & Everett St
Camas, WA

January 14, 2020
PBS Project 71070.000

Prepared by:
Robert Phipps, PLA, PWS
ISA Certified Arborist PN-8751A

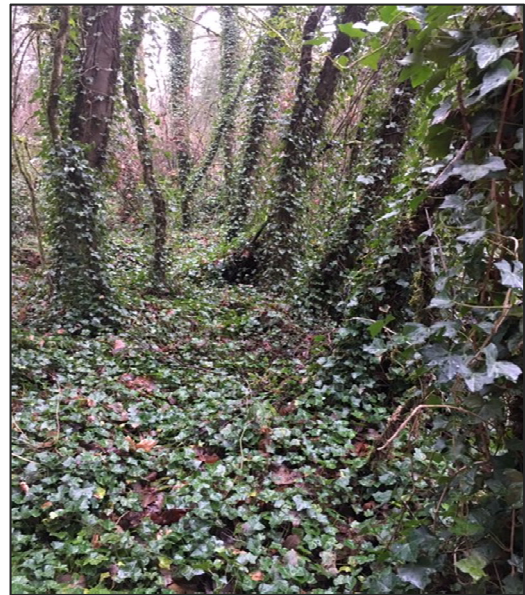
Establishment of English Ivy

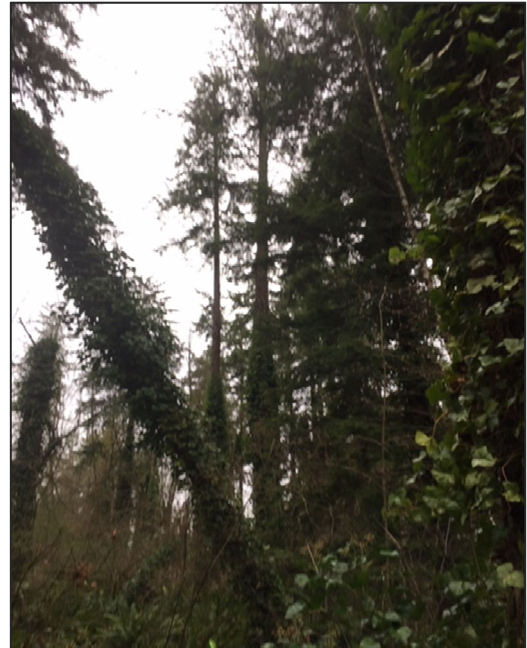
Much of the existing trees are subject to thick established English ivy (*Hedera helix*) in the understory. English ivy is a weedy, invasive, clinging evergreen vine that has taken over close to 90% of the understory native species. The English Ivy in thick bands have attached to the trees' outer layer of bark producing continued biotic stress. Most of the trees have English ivy vines reaching 10' or more up the trunks, adding additional weight to already stressed trees, and deterring production of proper vertical arrangement of scaffold branching, competing for nutrient, water and oxygen availability and suppressing native wildlife habitat. As of 2018, English Ivy is a WA State Class C noxious weed. Class C species are regulated for control but not required under this classification.

English Ivy adding additional stress and promoting early failure

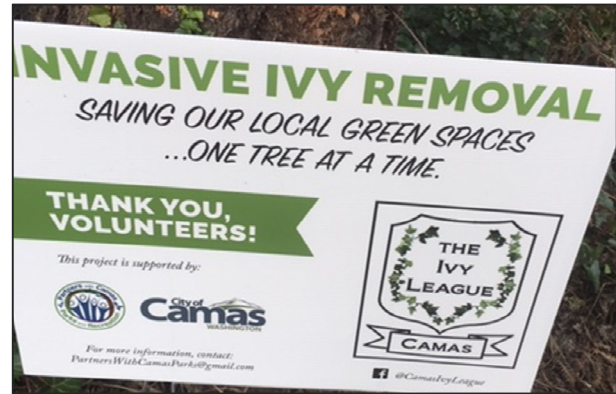
Volunteer opportunities for post construction monitoring and management of invasive weeds are already available

It is recommended that monitoring should be facilitated for the areas where preservation occurs, especially for larger trees that are more susceptible to stress. The below 10 year monitoring cycle is an option that could be introduced.

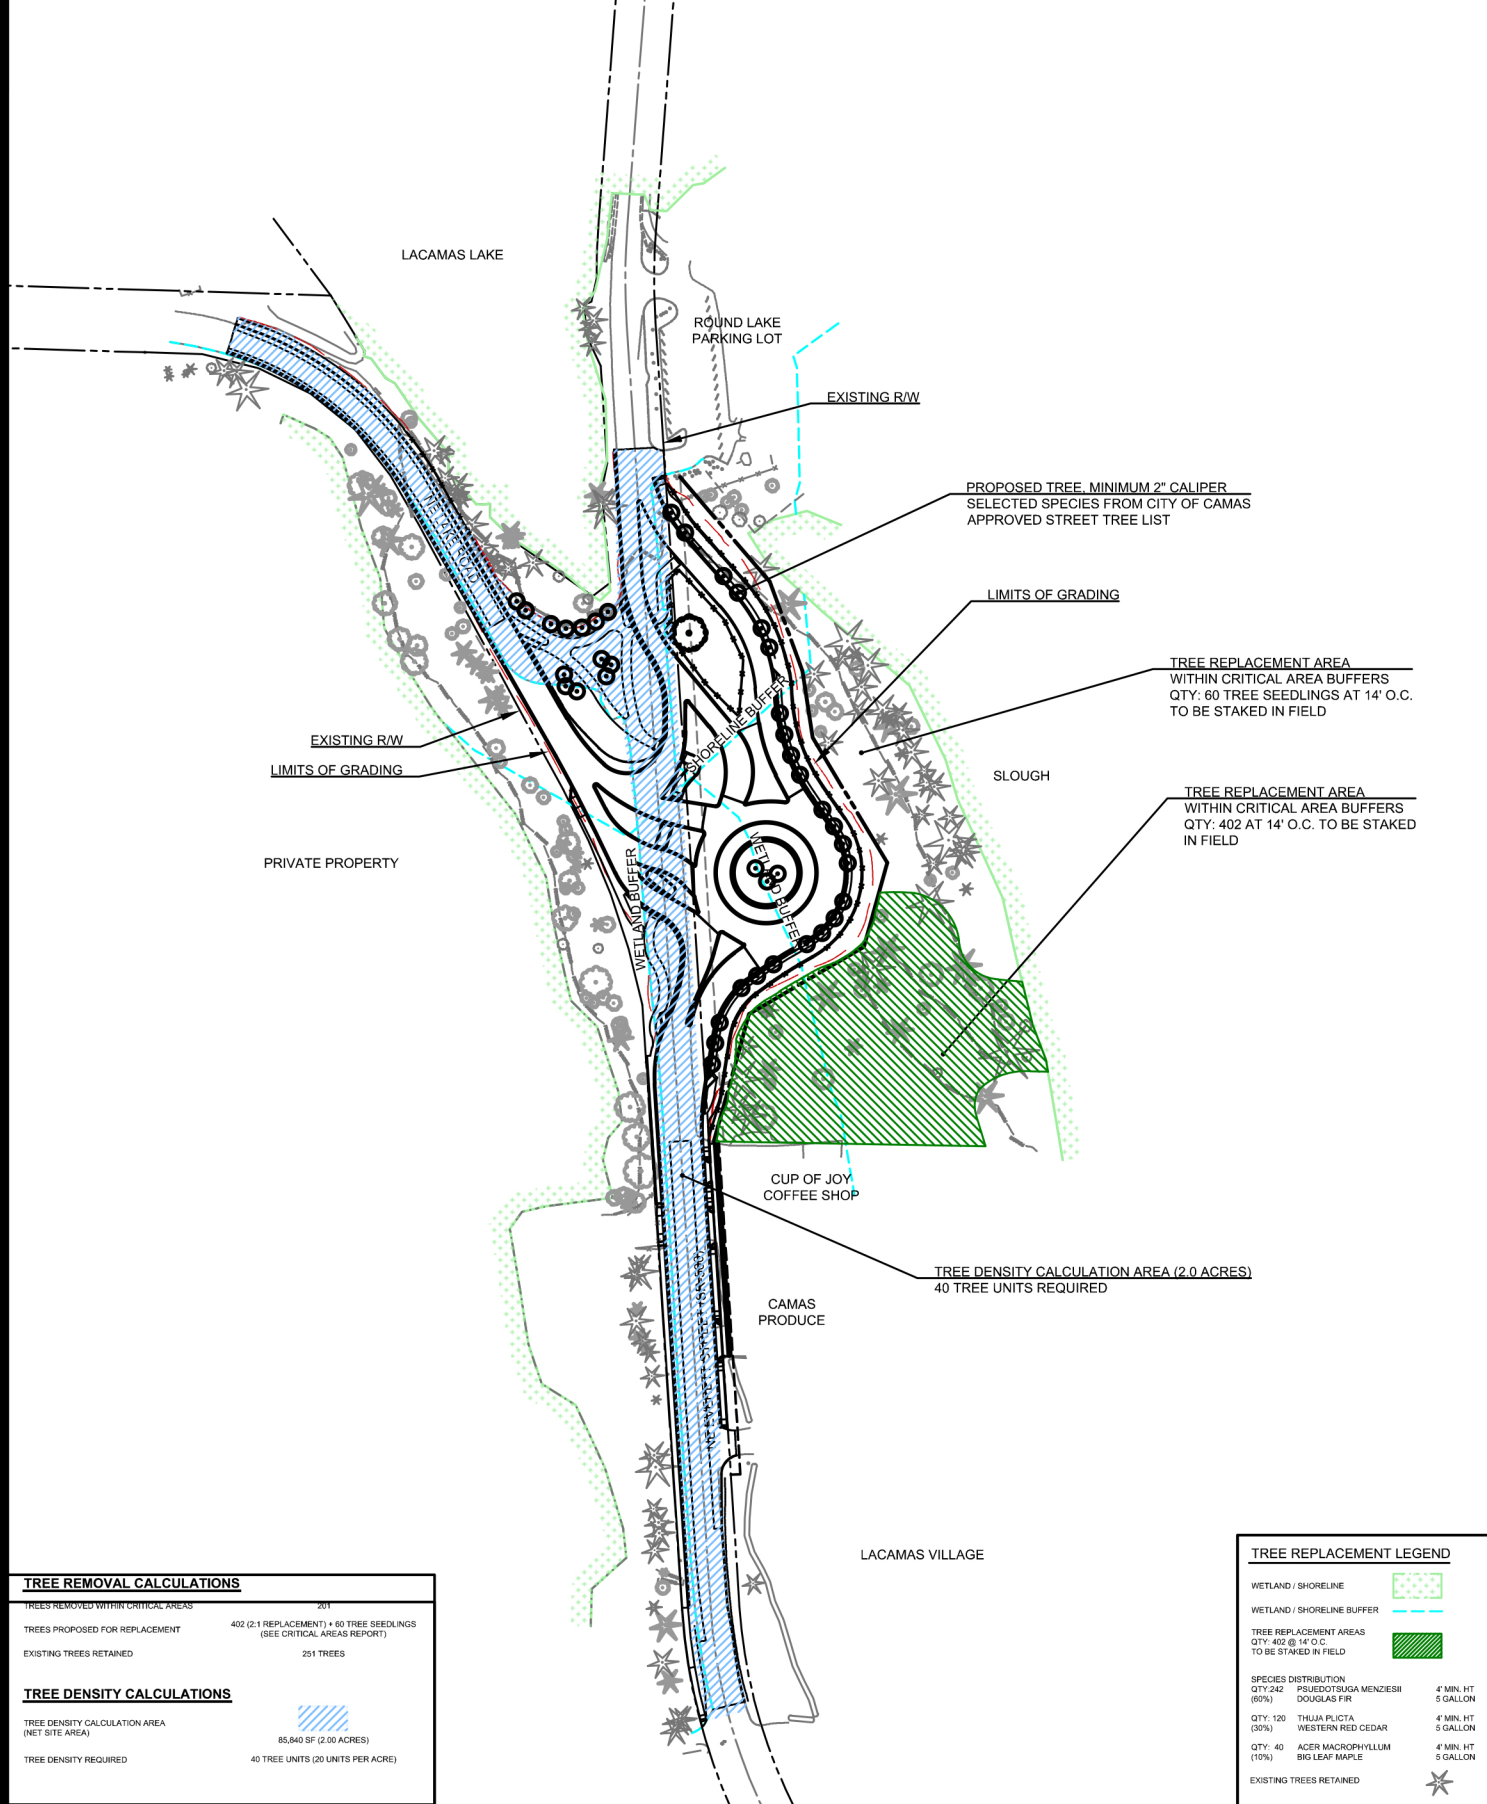
Landscape, Tree and Vegetation Plan

TREE REMOVAL CALCULATIONS	
TREES REMOVED WITHIN CRITICAL AREAS	201
TREES PROPOSED FOR REPLACEMENT	402 (2:1 REPLACEMENT) + 60 TREE SEEDLINGS (SEE CRITICAL AREAS REPORT)
EXISTING TREES RETAINED	251 TREES
TREE DENSITY CALCULATIONS	
TREE DENSITY CALCULATION AREA (NET SITE AREA)	85,840 SF (2.00 ACRES)
TREE DENSITY REQUIRED	40 TREE UNITS (20 UNITS PER ACRE)

201 trees (within proposed construction limits and hazard tree removal) are proposed to be removed within the critical area buffers. Following CMC requirements, a minimum of 402 trees will be required to be installed. Tree species will include native species of Douglas Fir (60%), Western Red Cedar (30%) and Big Leaf Maple (10%).

TREE REPLACEMENT LEGEND		
WETLAND / SHORELINE		
WETLAND / SHORELINE BUFFER		
TREE REPLACEMENT AREAS QTY: 402 @ 14' O.C. TO BE STAKED IN FIELD		
SPECIES DISTRIBUTION		
QTY: 242	PSUEDOTSUGA MENZIESII	4' MIN. HT
(65%)	DOUGLAS FIR	5 GALLON
QTY: 120	THUJA PLICATA	4' MIN. HT
(30%)	WESTERN RED CEDAR	5 GALLON
QTY: 40	ACER MACROPHYLLUM	4' MIN. HT
(10%)	BIG LEAF MAPLE	5 GALLON
EXISTING TREES RETAINED
